**SURVEY  
23 NORTHAM AVENUE  
LLANRUMNEY  
CARDIFF  
CF3 4JP**

**FOR  
MOLLY MURPHY  
AND  
DANIEL SMITH**

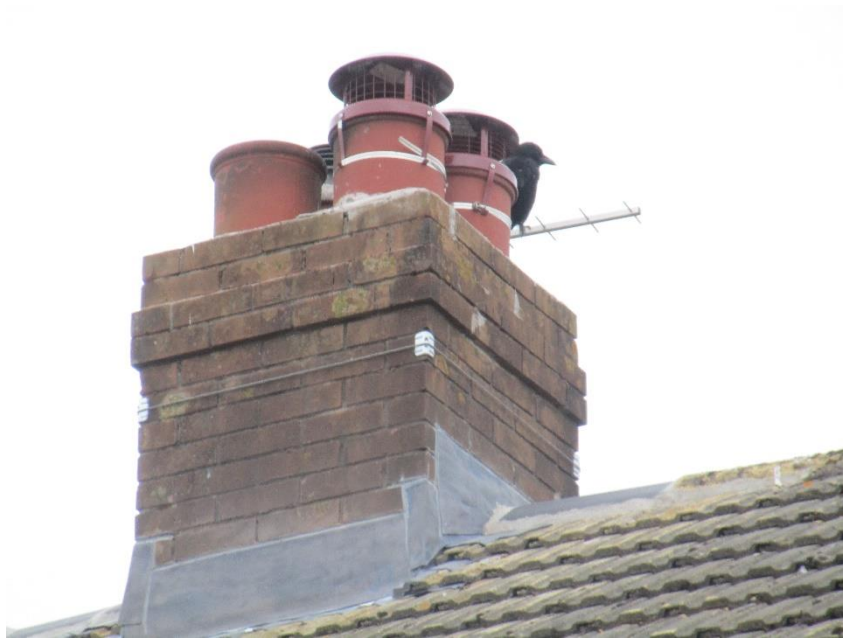
- 03 Exterior – Party Chimney stack – no major defects noted – unable to see cement bedding mortar to pots.

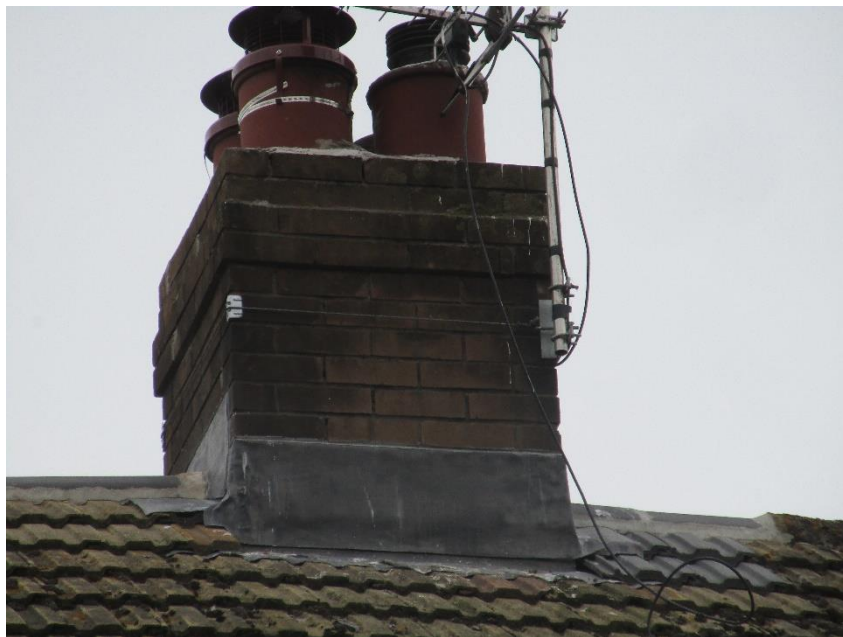
- 04 Exterior – Chimney from the rear.

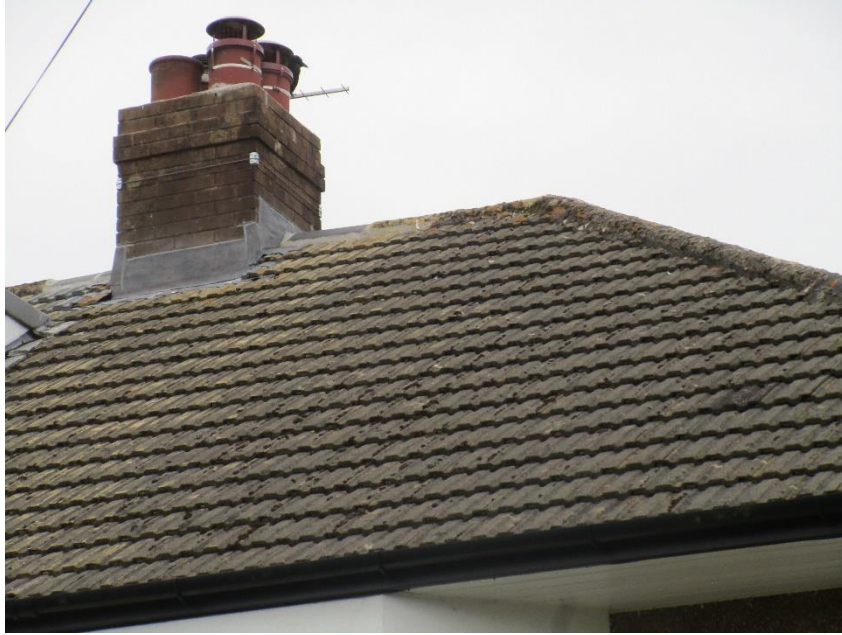
05 Exterior – Concrete interlocking tile roof covering – moss and lichen growth noted – not excessive.

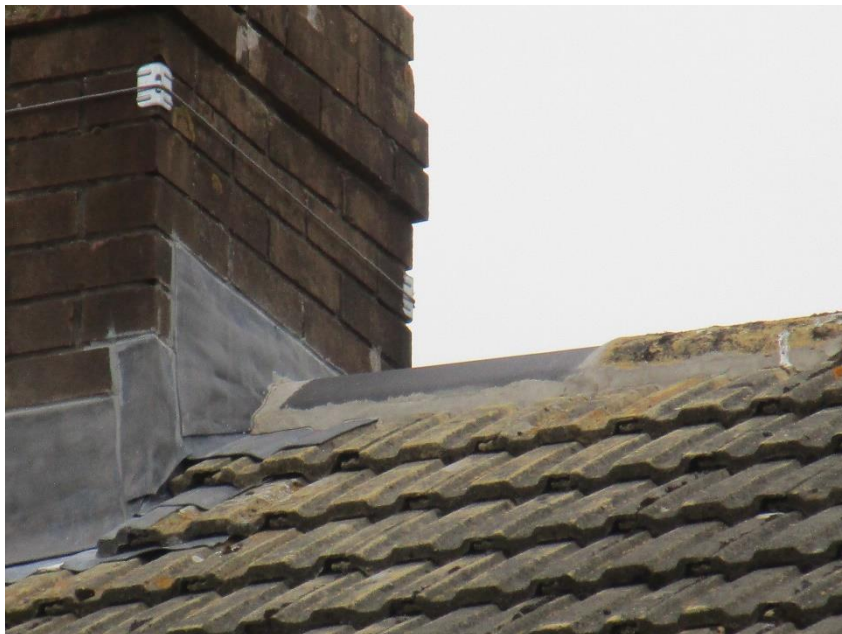
06 Exterior – Replacement ridge tile – fitted to a reasonable standard.

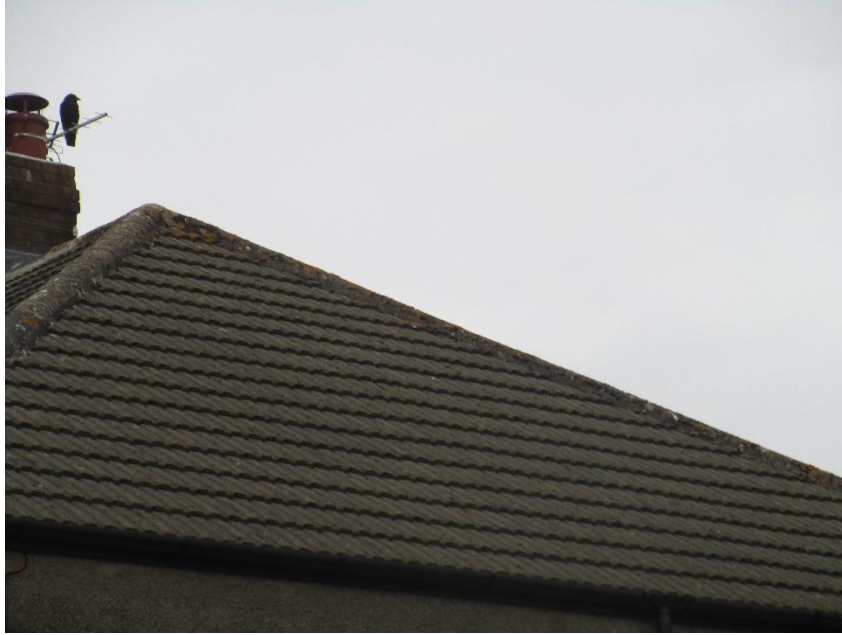
07 Exterior – Side of Main roof – moss and lichen growth – not excessive.

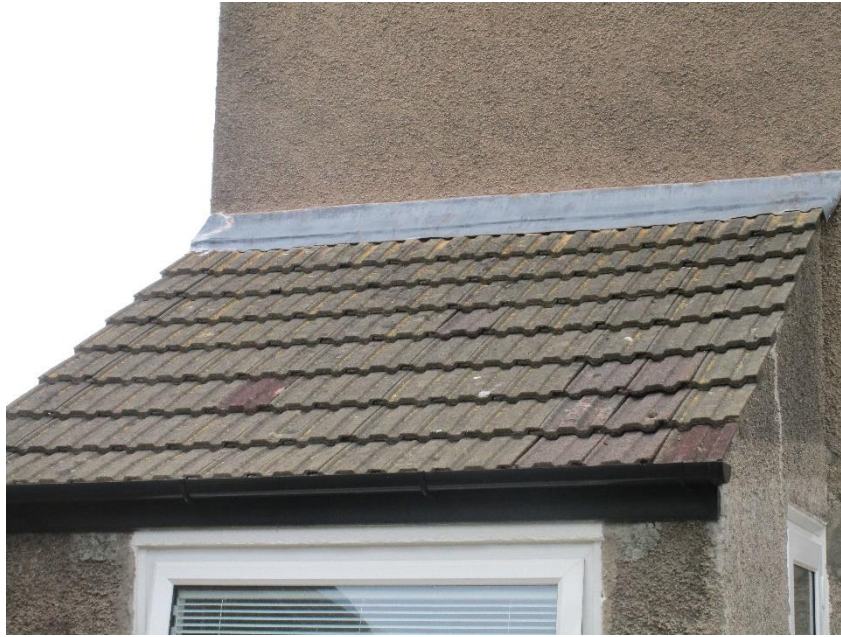
09 Exterior – Rear extension roof covering – replacement tiles noted – weatherproofed to rear wall in lead.

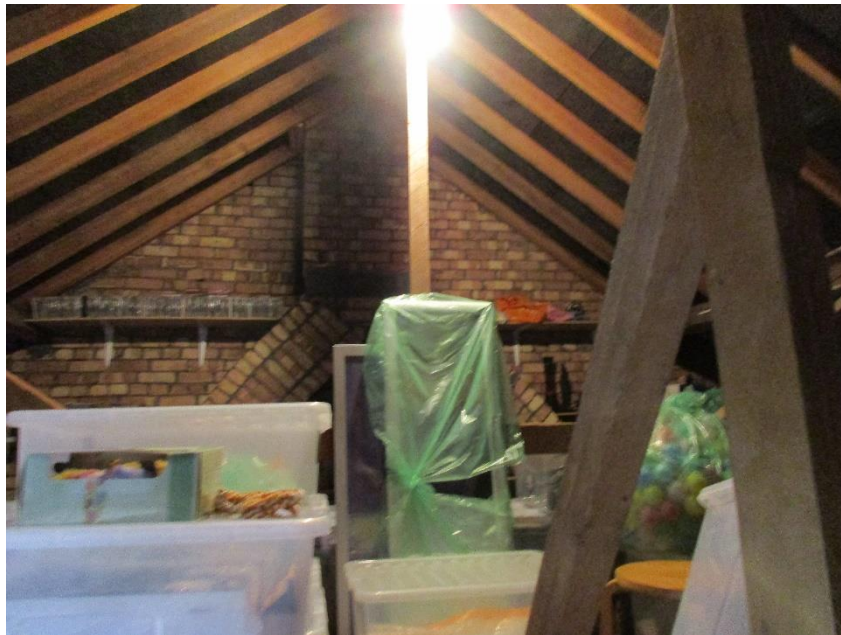
10 Interior – Roof Void – Cut timber roof structure and bituminous under felting.

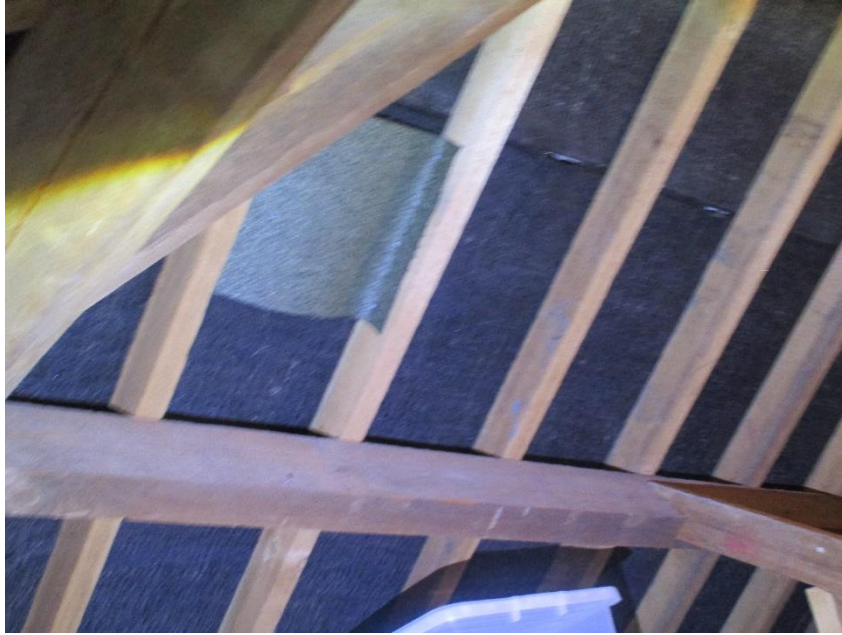
11 Interior – Roof Void – Patch repair to under felting.

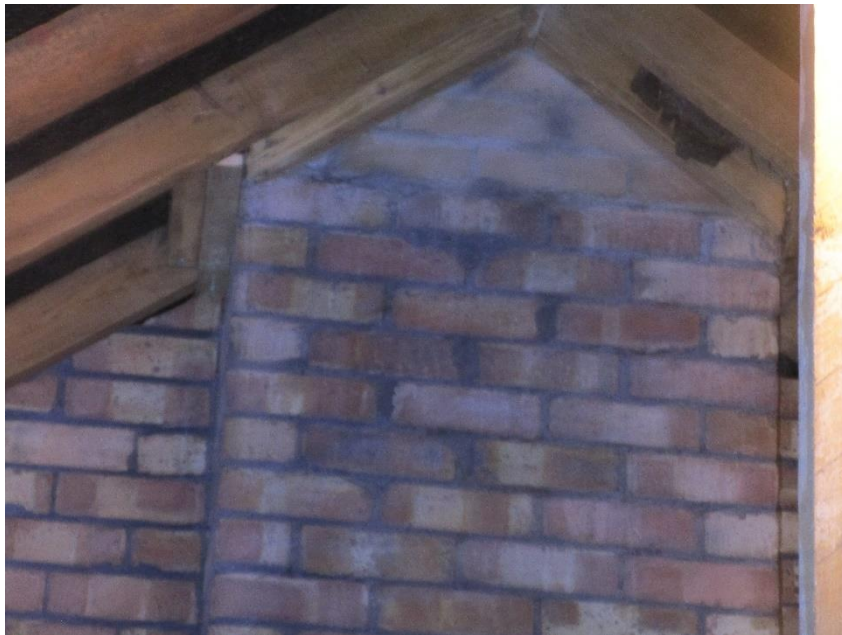
12 Interior – Roof Void – Party wall fully built up – staining to chimney – appears historic.

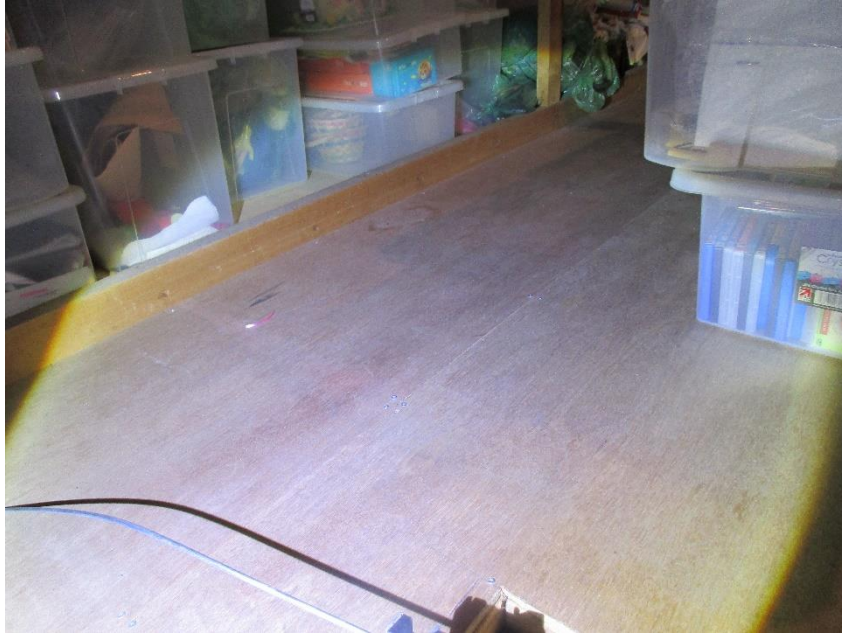
13 Interior – Roof Void – Boarding over blanket insulation will reduce its efficiency.

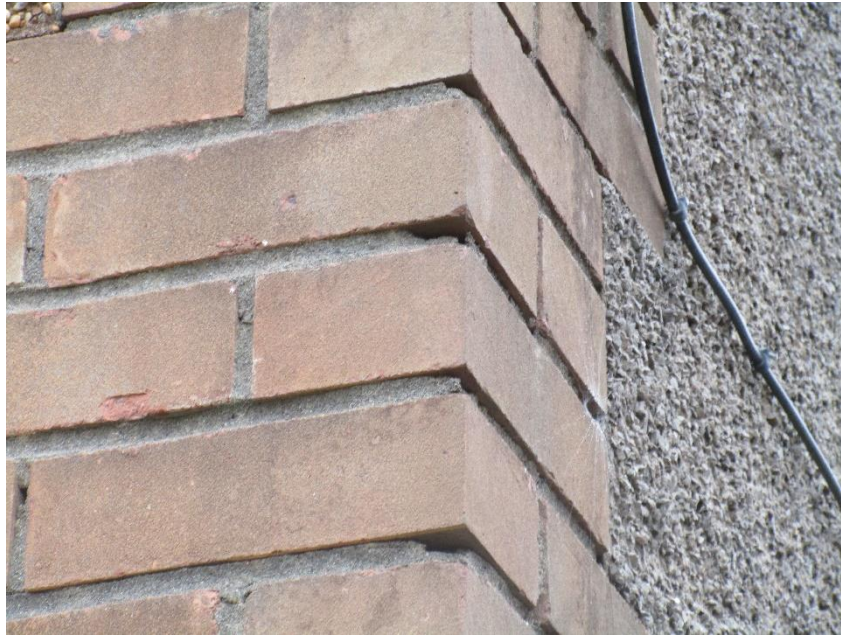
- 15 Exterior – Gaps and wear noted to pointing – localised repairs to pointing will be required.

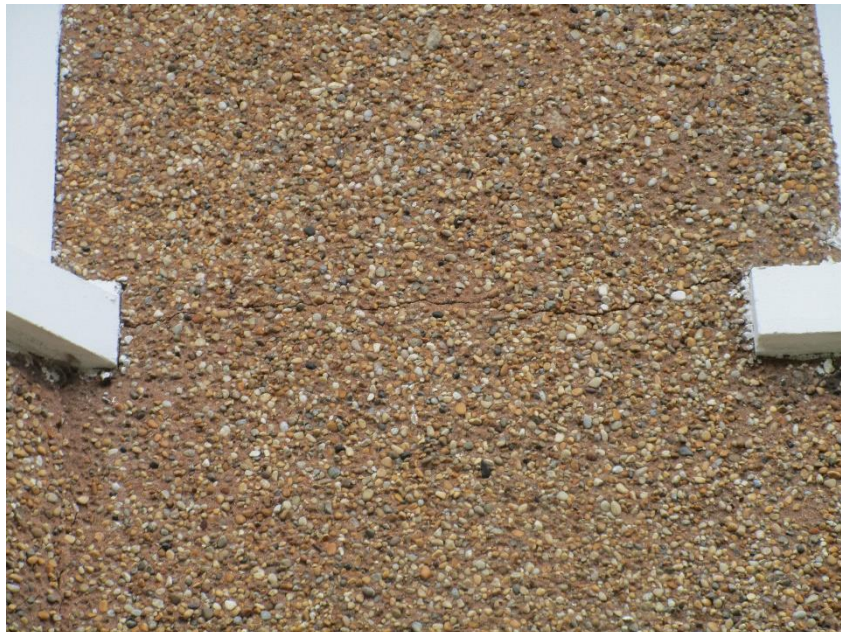
- 16 Exterior – Crackling to render consistent with wall tie failure noted.

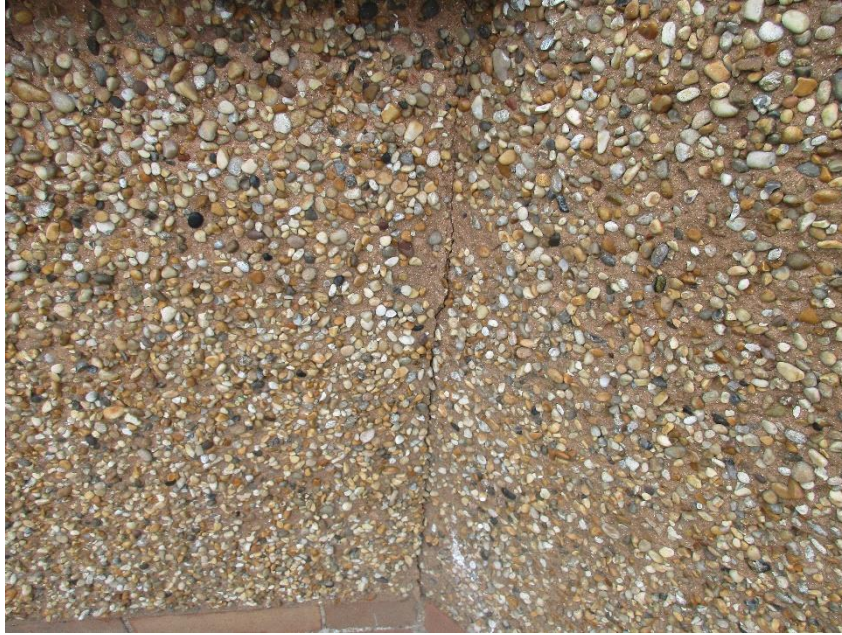
- 17 Exterior – Cracking to render at abutment between bay window and front elevation – periodic repairs will be required.

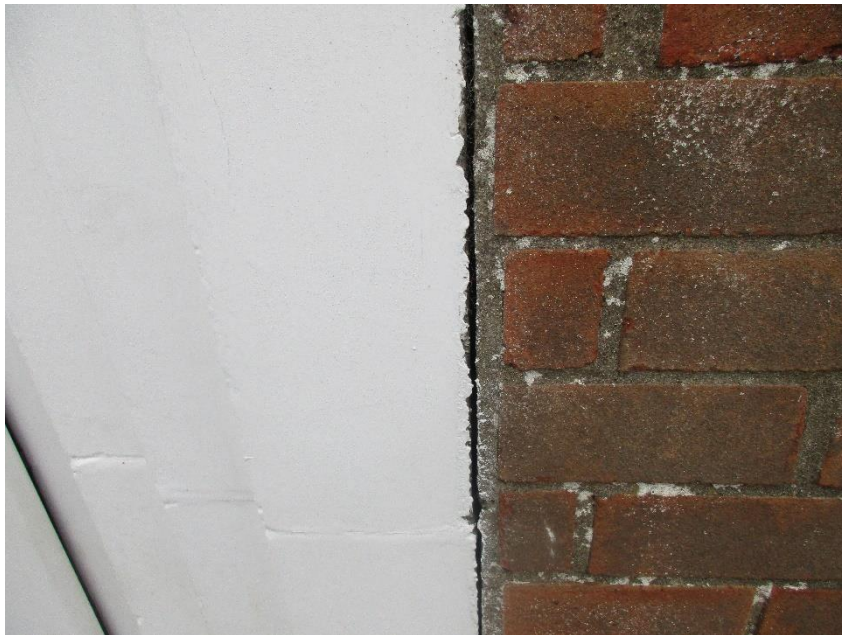
- 18 Exterior – Gaps between the concrete detail around openings and brickwork should be filled.

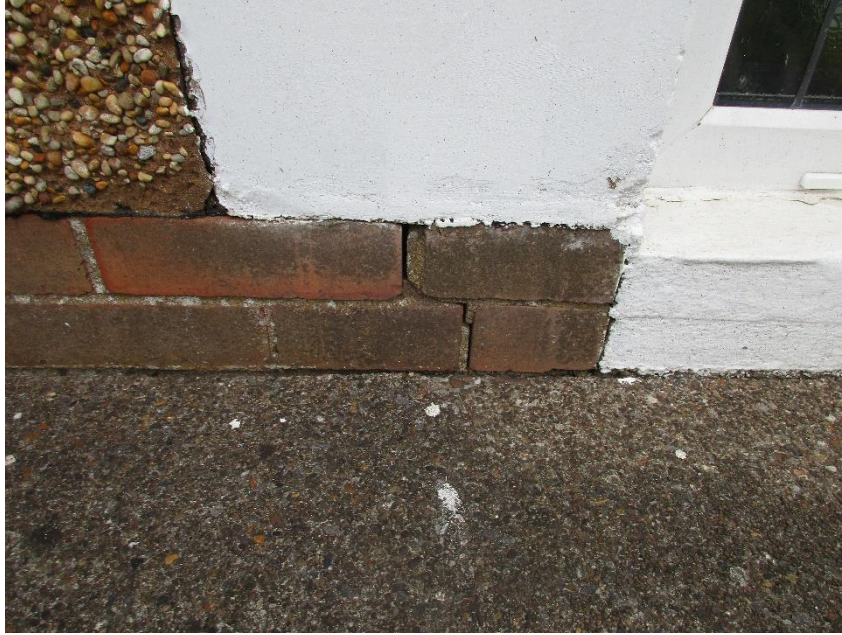
19 Exterior – Pointing repairs required to brickwork to low level – DPC visible.

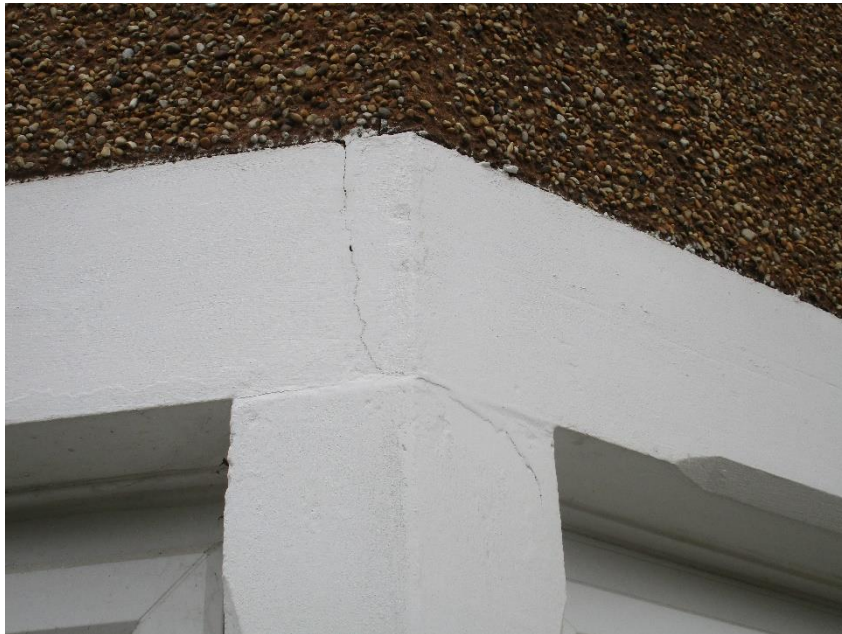
20 Exterior – Cracking to concrete to bay window – not excessive – periodic repairs and re-decoration will be required.

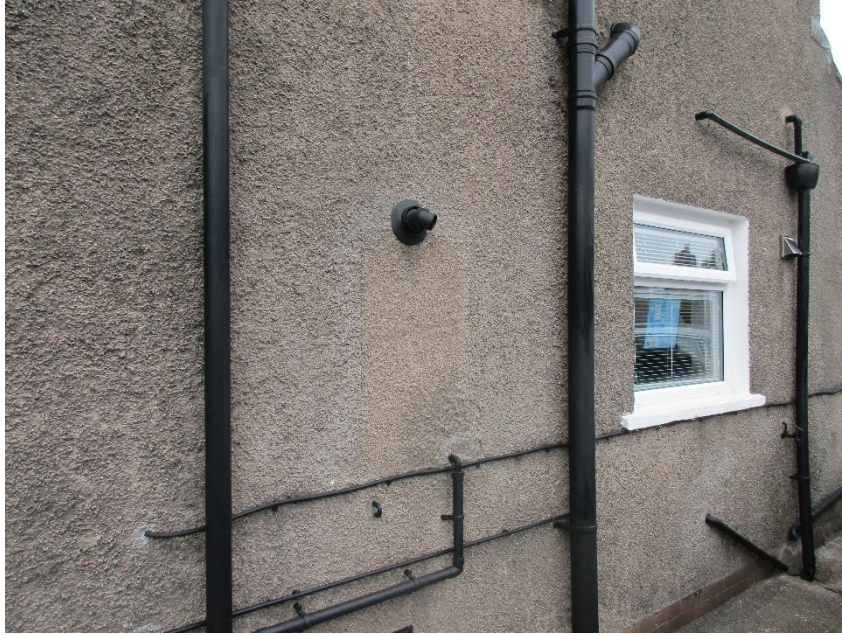
21 Exterior – Evidence of window infill to side elevation.

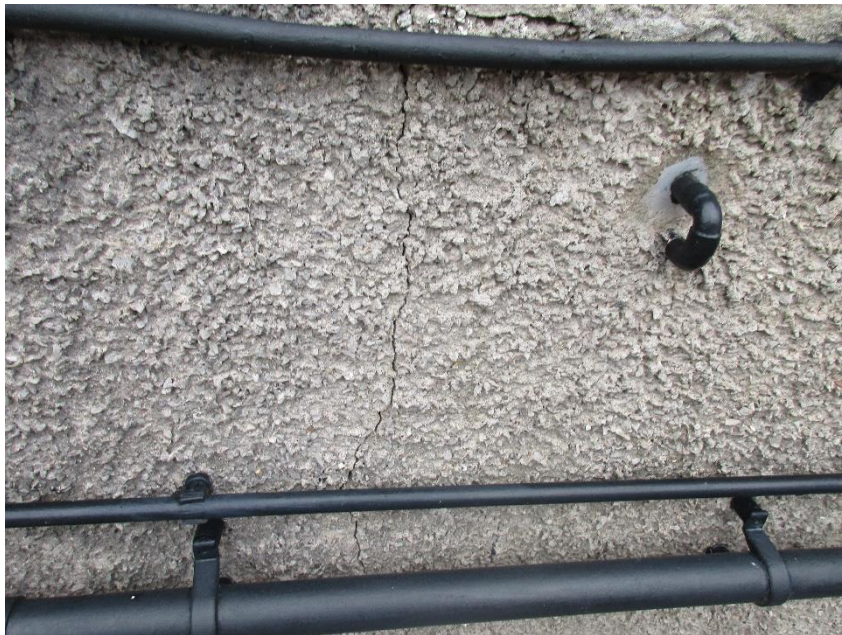
22 Exterior – Cracking and hollow render noted – repairs will be required.

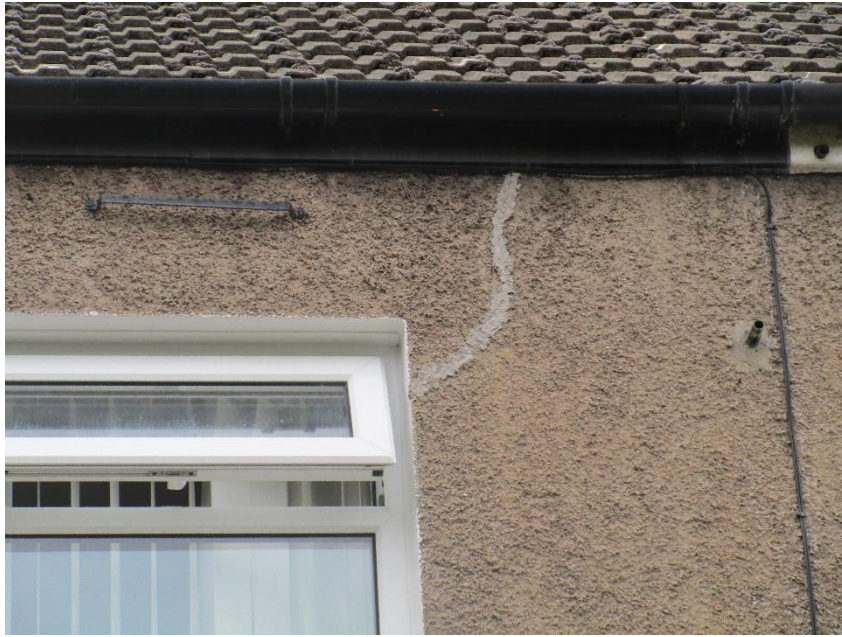
23 Exterior – Repairs to cracks to rear elevation – poorly finished.

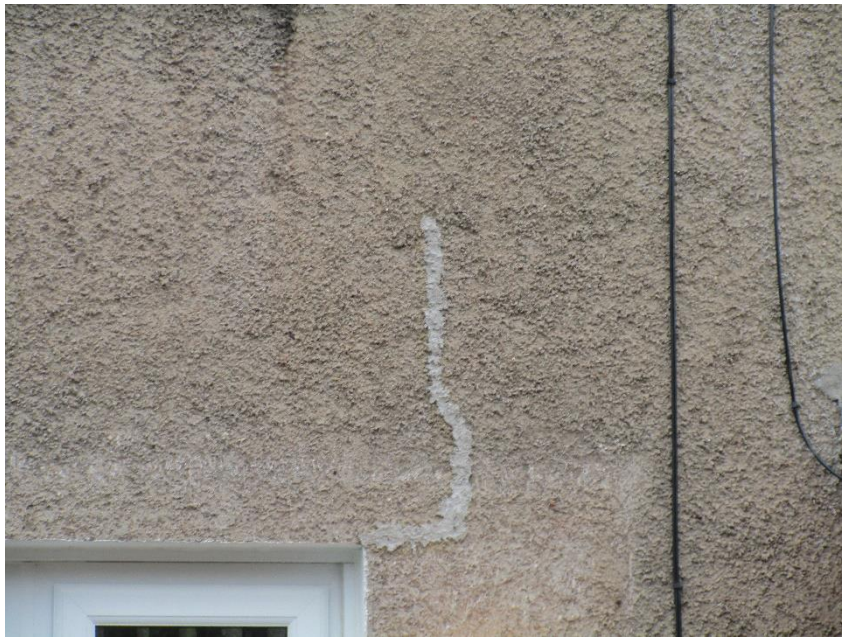
24 Exterior – Repairs to cracks to rear elevation – poorly finished.

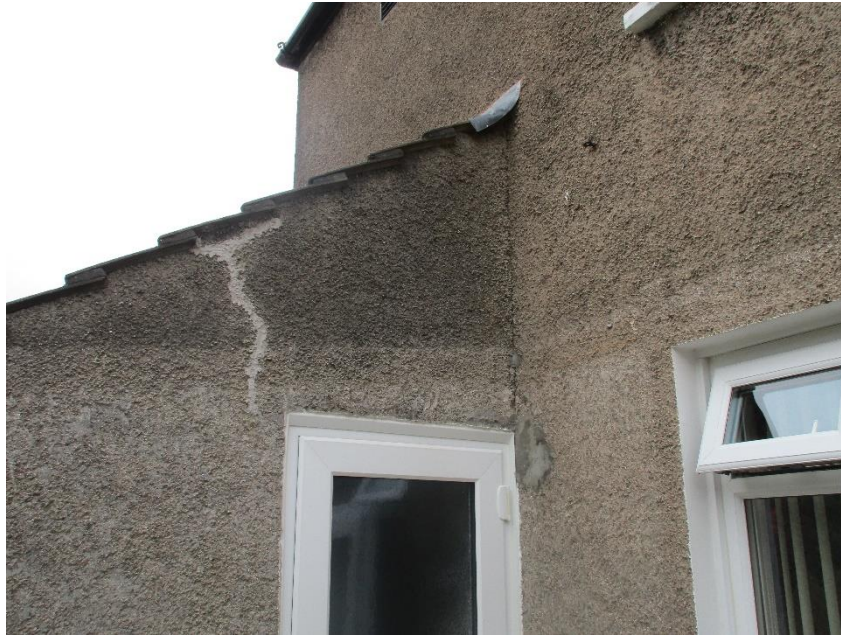
- 25 Exterior – Repairs to cracks to rear extension – cracking at abutment between the extension and rear elevation – periodic repairs will be required.

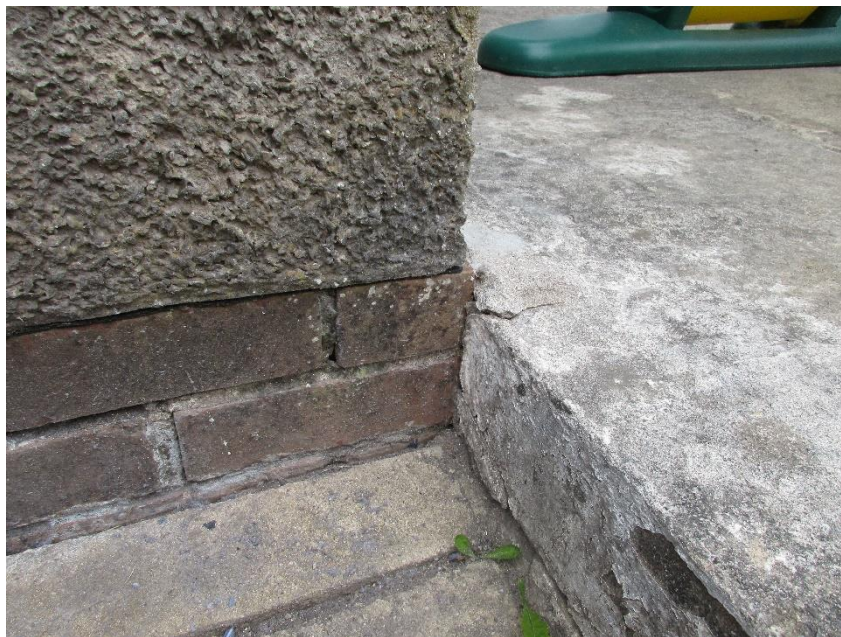
- 26 Exterior – Concrete slab has raised external ground level – a gap of 2 courses of bricks (150mm) should be maintained.

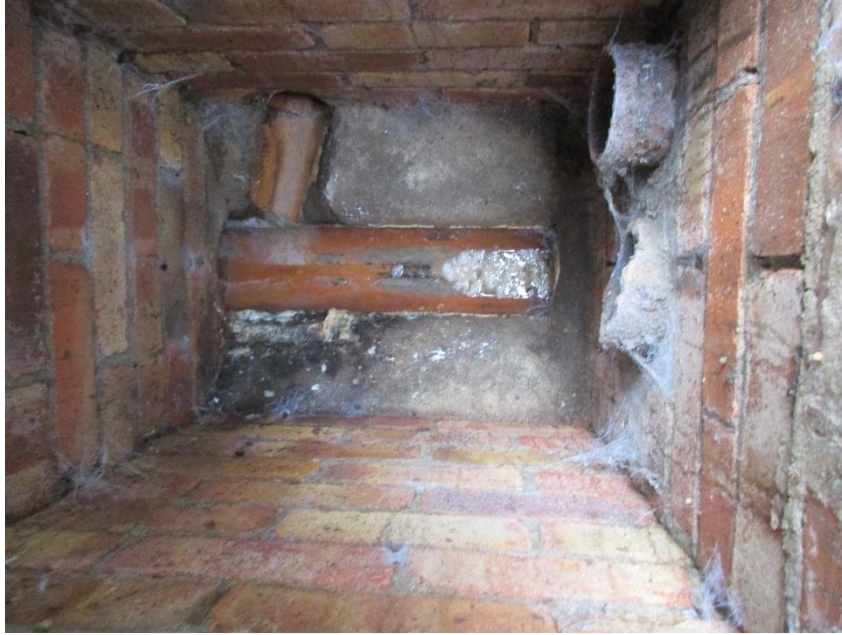
31 Exterior – Inspection chamber was in reasonable condition – some waste matter noted, this can be easily cleared.

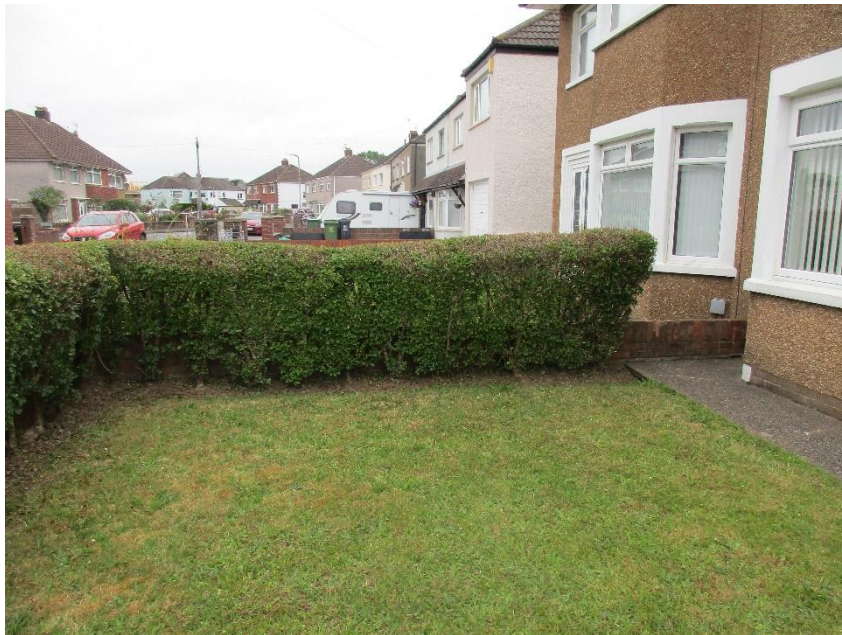
32 Exterior – Front left boundary.

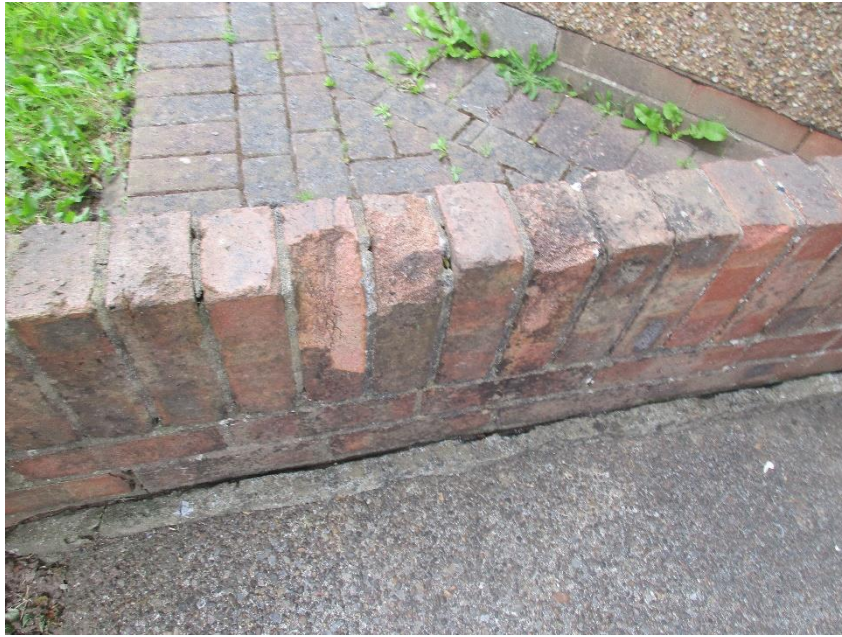
33 Exterior – Front left boundary – damage noted to bricks.

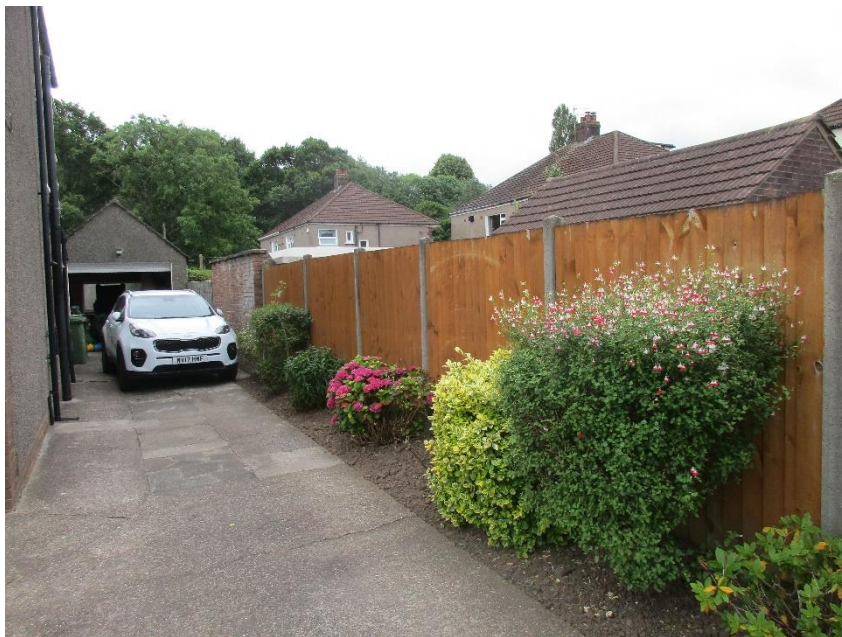
34 Exterior – Front right boundary.

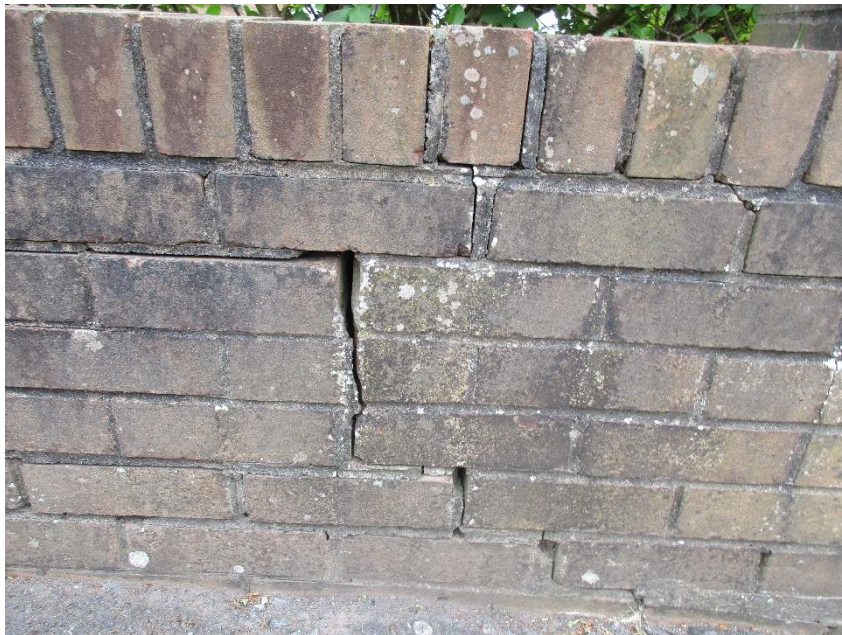
36 Exterior – Front Boundary – cracking to brickwork.

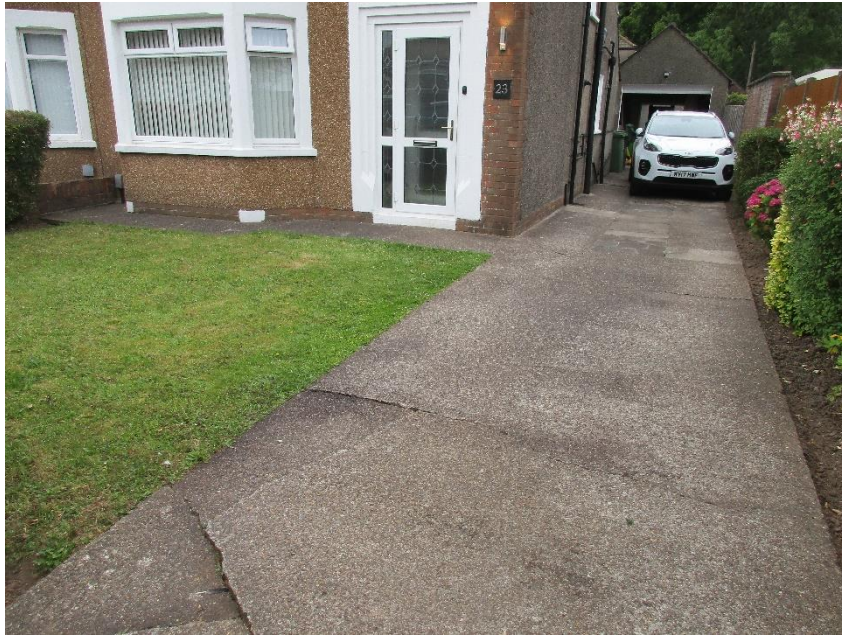
37 Exterior – Frontage – cracking and unevenness to concrete driveway and pathways.

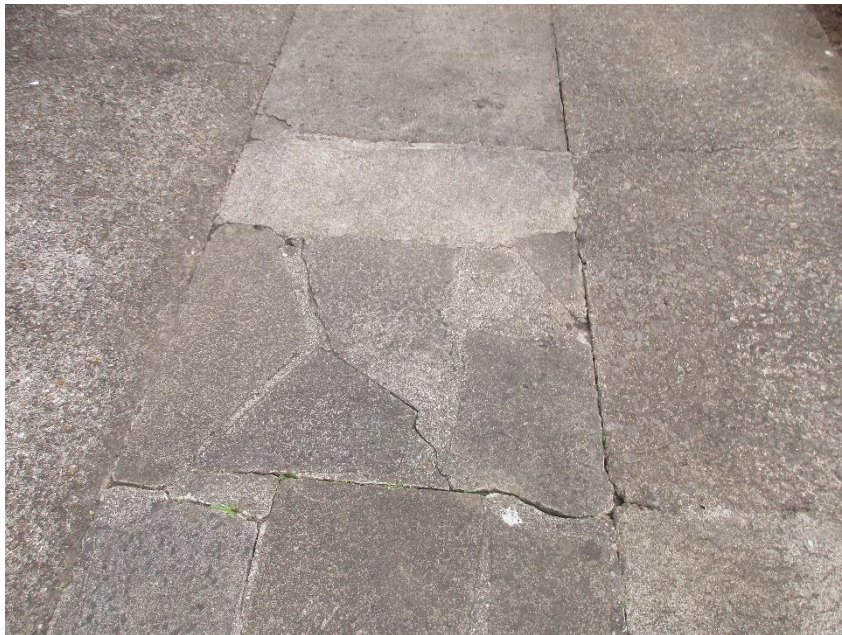
38 Exterior – Frontage – cracking and unevenness to driveway and pathways.

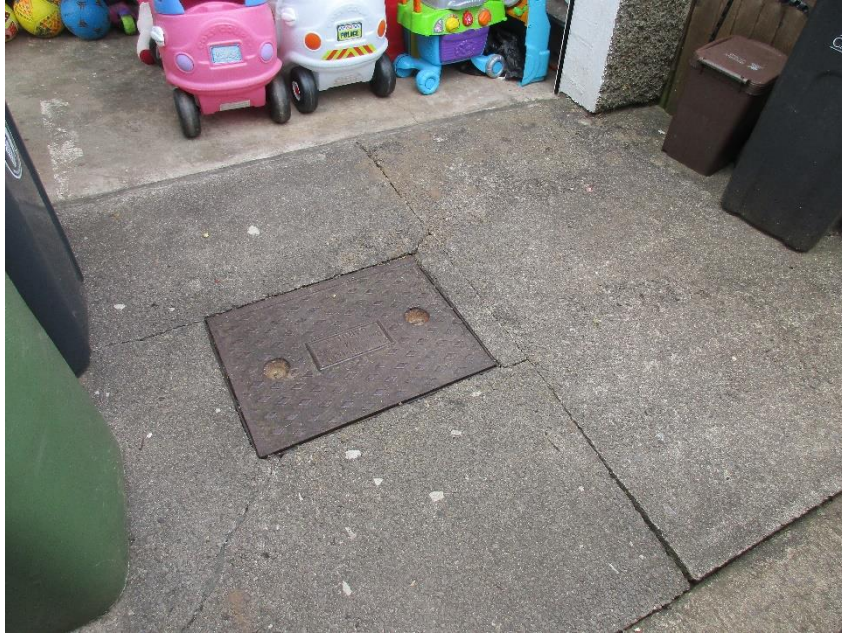
39 Exterior – Frontage – cracking and unevenness to concrete driveway and pathways.

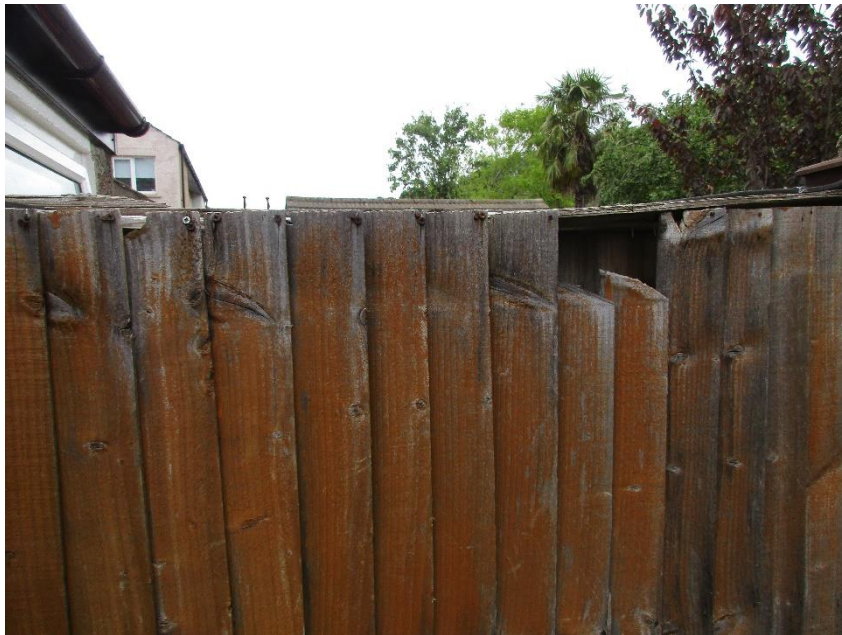
40 Exterior – Damage to timbers between driveway and rear garden.

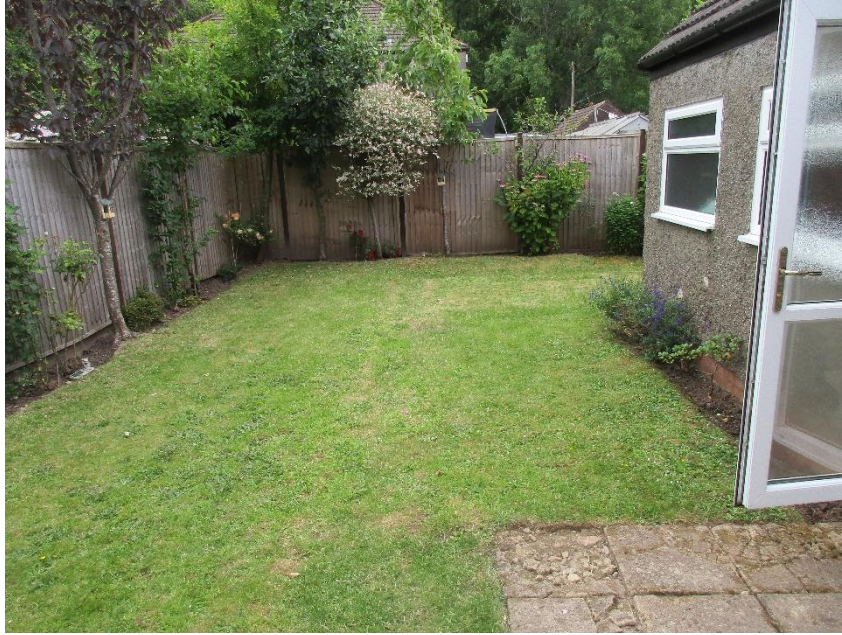
41 Exterior – Rear Garden.

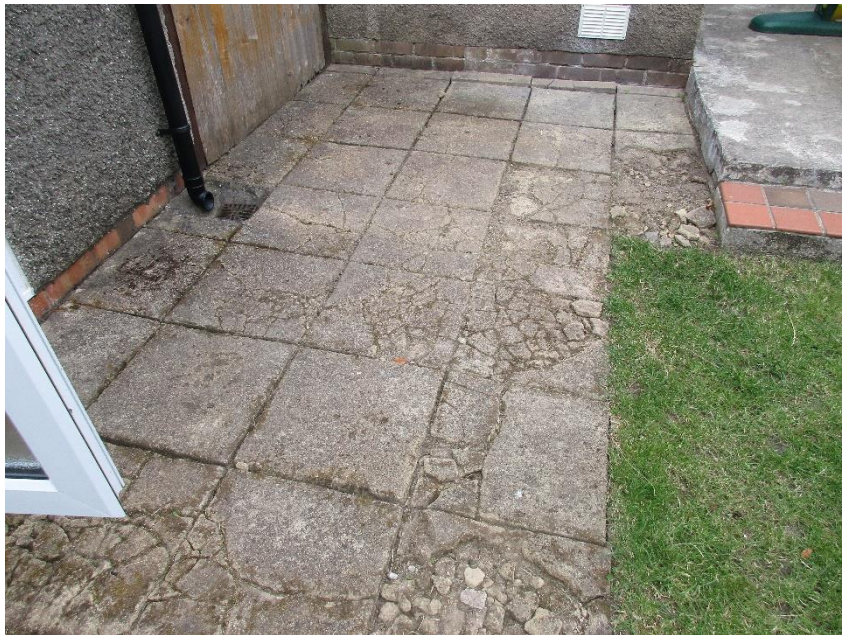
44 Exterior – Cracking, damaged and uneven patio slabs.

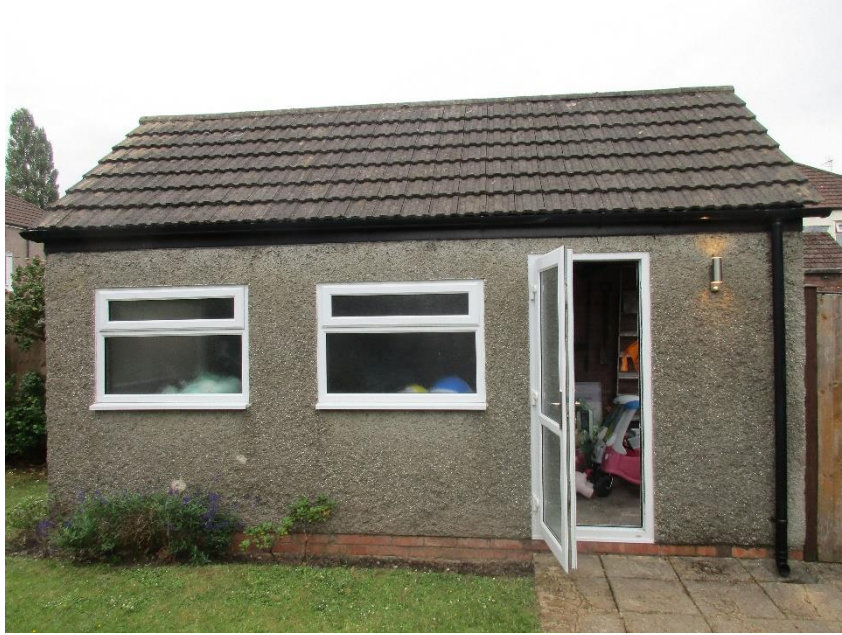
45 Exterior – Garage.

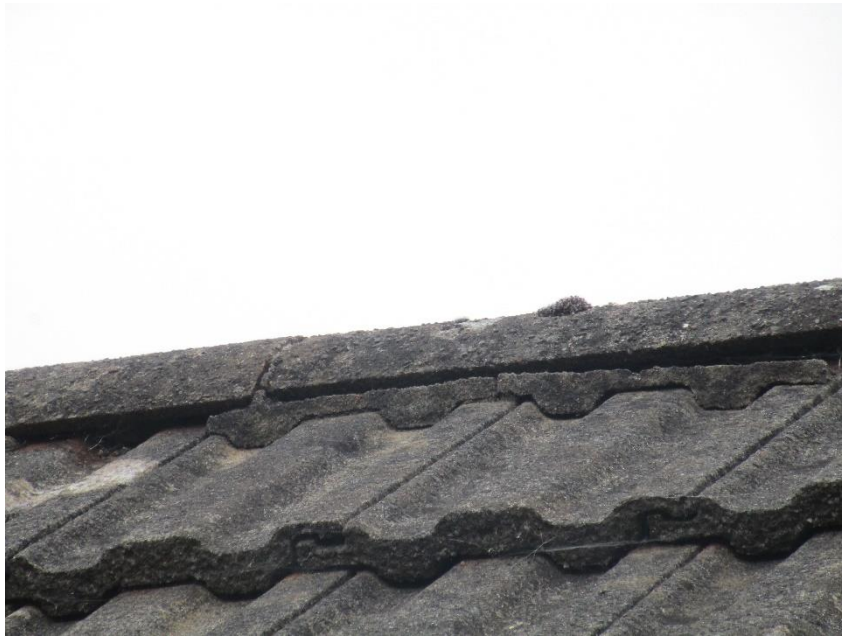
46 Exterior – Garage – Cracked and missing cement bedding mortar to ridge tile.

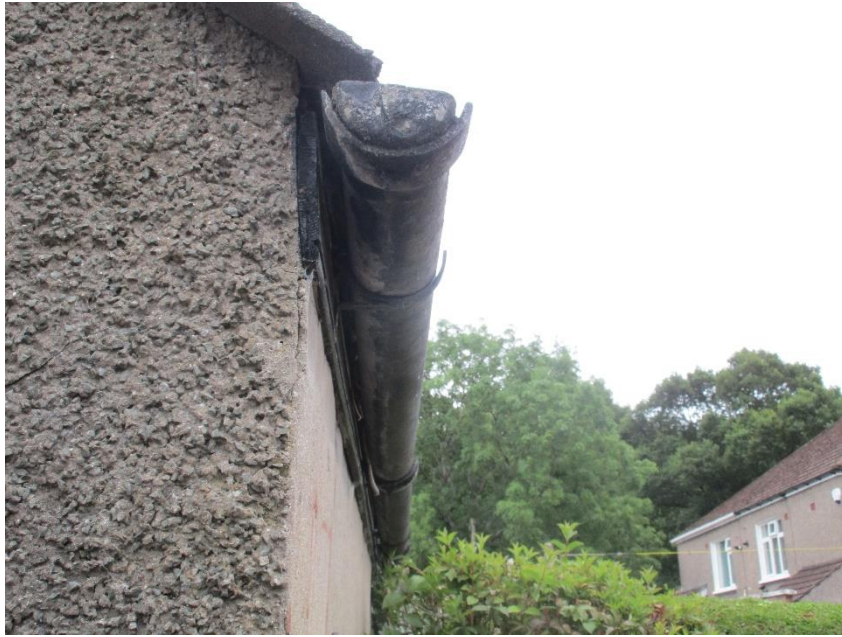
47 Exterior – Garage – Metal gutter to right side – limited inspection – cannot rule out asbestos.

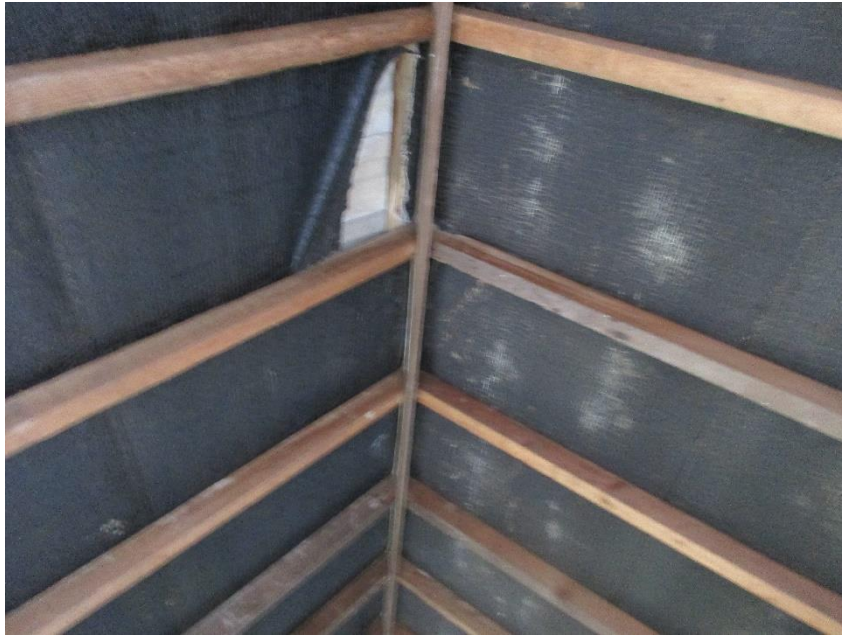
49 Interior – Garage – Tearing noted to under felting.

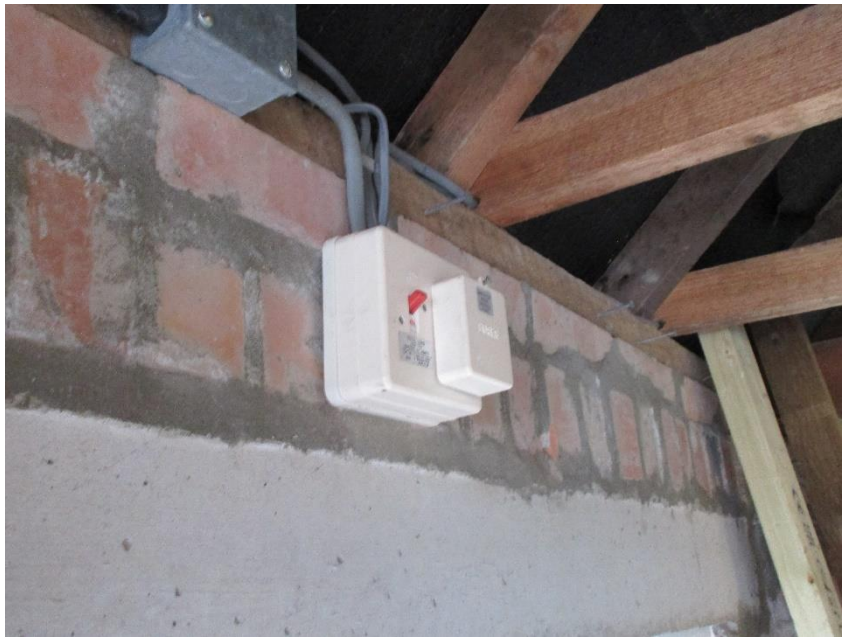
50 Interior – Garage – Wired consumer unit – periodic inspection required.

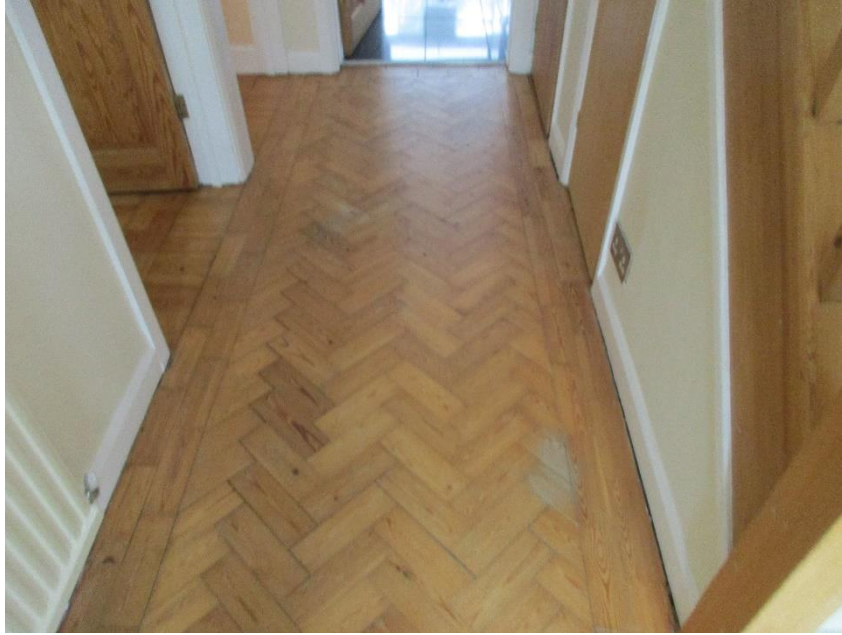
55 Interior – Entrance hallway – wear noted to parquet flooring.

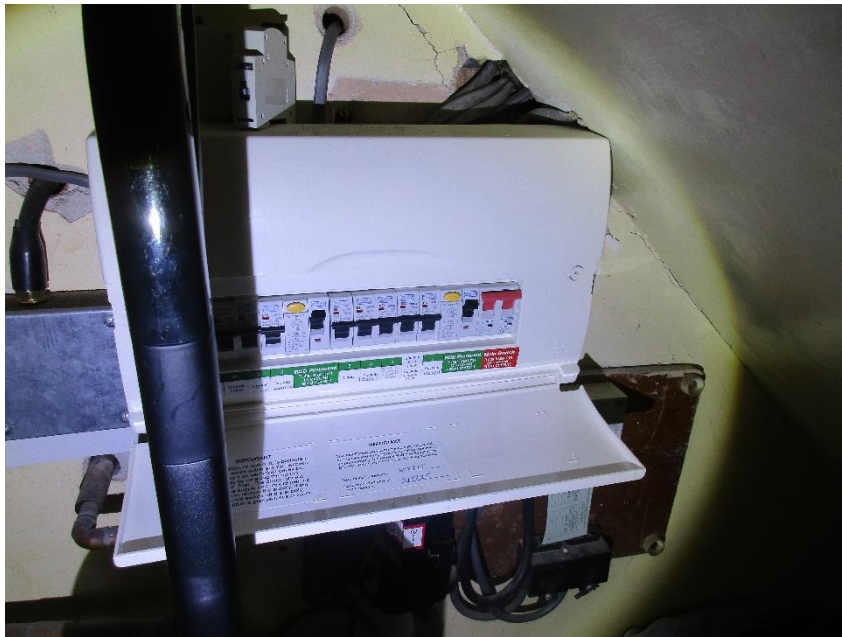
56 Interior – Entrance hallway – Under stair cupboard – consumer unit.

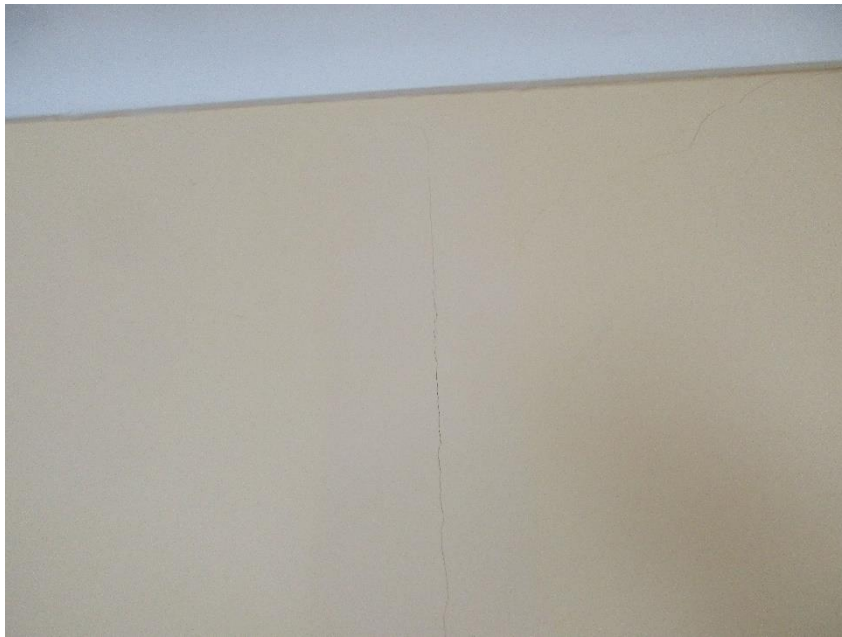
60 Interior – Lounge – Cracking to wall – joint between plasterboard and solid masonry to filled opening to dining room.
