**SURVEY  
23 NORTHAM AVENUE  
LLANRUMNEY  
CARDIFF  
CF3 4JP**

**FOR  
MOLLY MURPHY  
AND  
DANIEL SMITH**

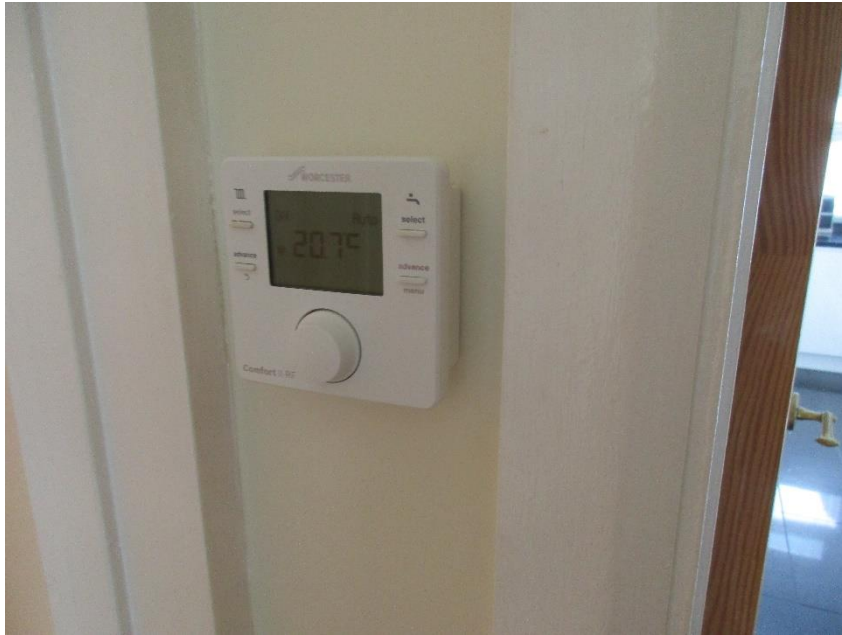
61 Interior – Hallway – Central heating thermostat.

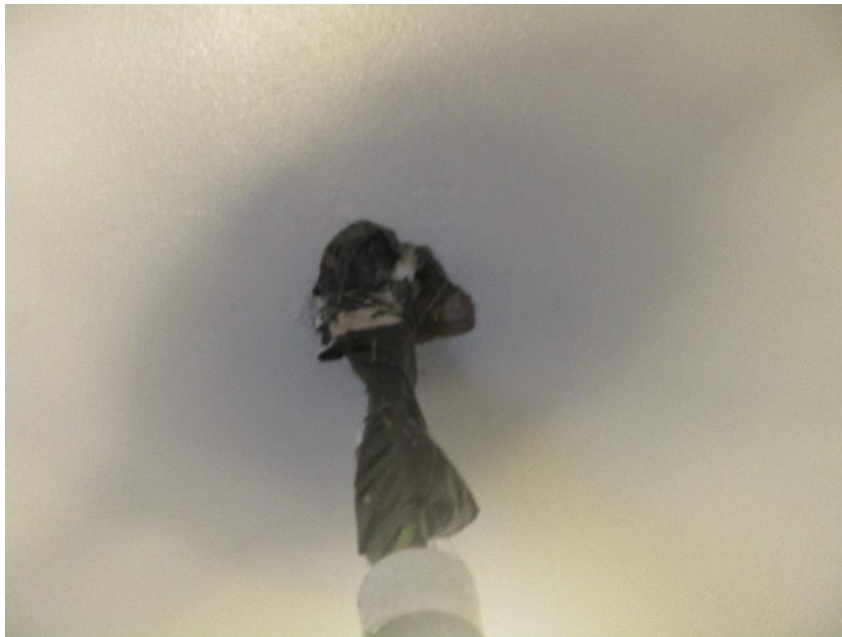
68 Interior – Landing – Bare wires to pendant – fitting is hanging and not secured – replacement required.

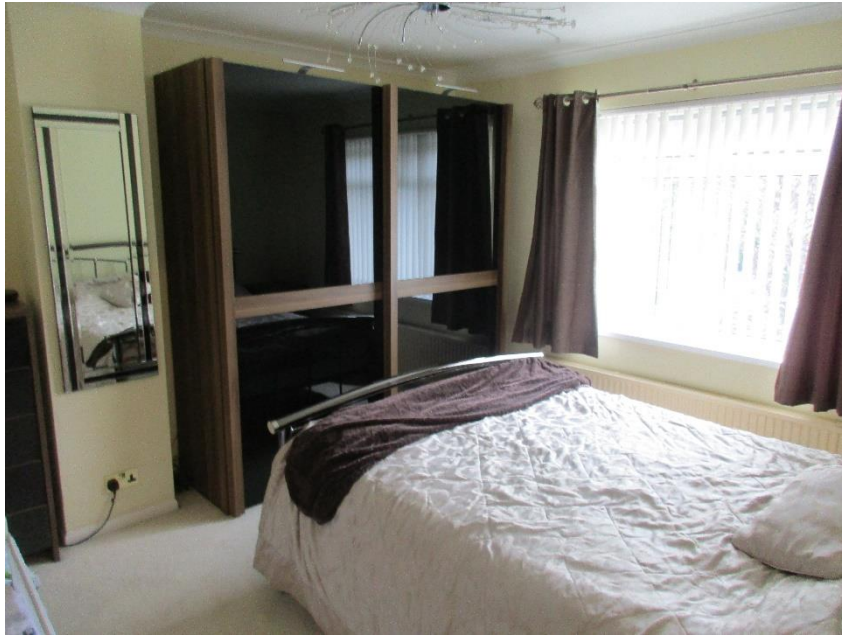
69 Interior – Bedroom One.

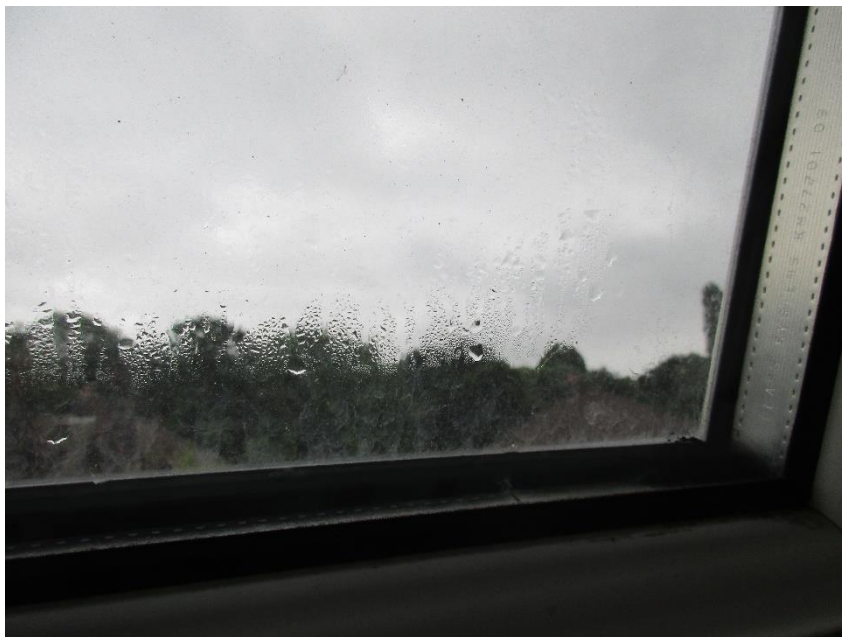
70 Interior – Bedroom One – Misting noted to glazing – seal has failed.

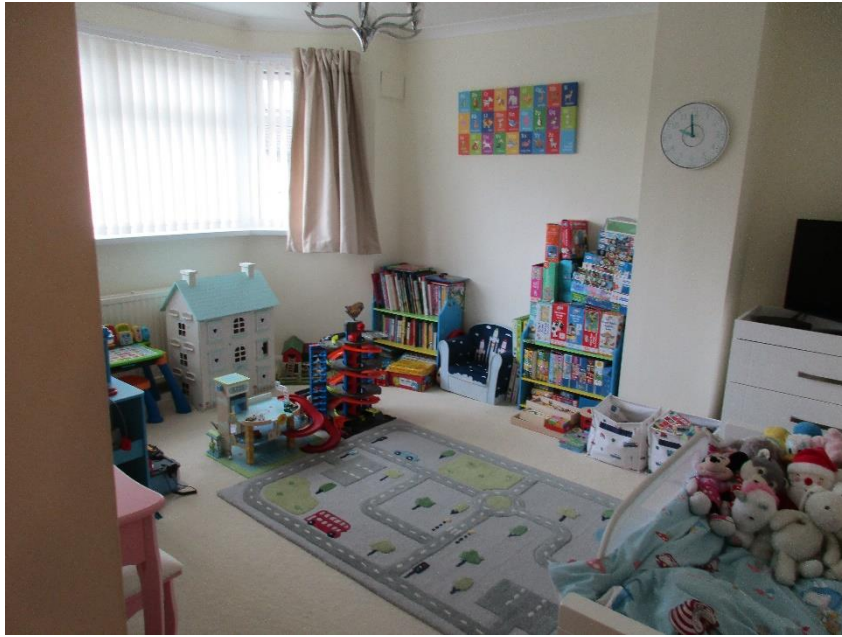
71 Interior – Bedroom Two.
